A Boughey Pty Ltd at Collahuasi Mine - Chile

Ball Mill Failures

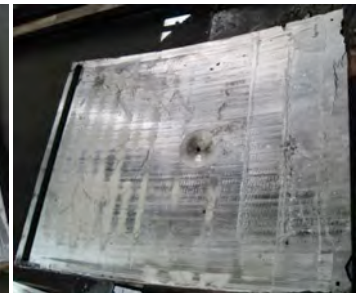
Damage to the main support bearing pads was evident on both the feed and discharge ends of the mill, with catastrophic failure of one pad observed on the discharge end bearing. There was a significant amount of cracking in the babbitt, most likely as a result of heat stress (see photos to the right).

The evidence from the failure mode assessment suggests that the failure was primarily the result of a breakdown of the lubricant film due to contamination. There was significant evidence of high levels of contamination in the oil sampling records.
