A Boughey Pty Ltd at Collahuasi Mine - Chile

Ball Mill Failures

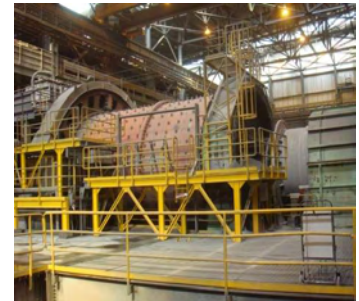
In March 2012, A Boughey Pty Ltd was contracted to inspect and audit all the grinding mills operating at Collahuasi. The mills were inspected whilst in operation and during shutdown conditions. Consideration was given to mechanical, electrical and hydraulic operating aspects of those

components that were accessible during the visit. An inspection and audit report was prepared for the client, encompassing critical parts that needed repair or replacement, as well as recommendations on maintenance and operating process improvements for each mill and its surroundings.
